Ice Damming Basics

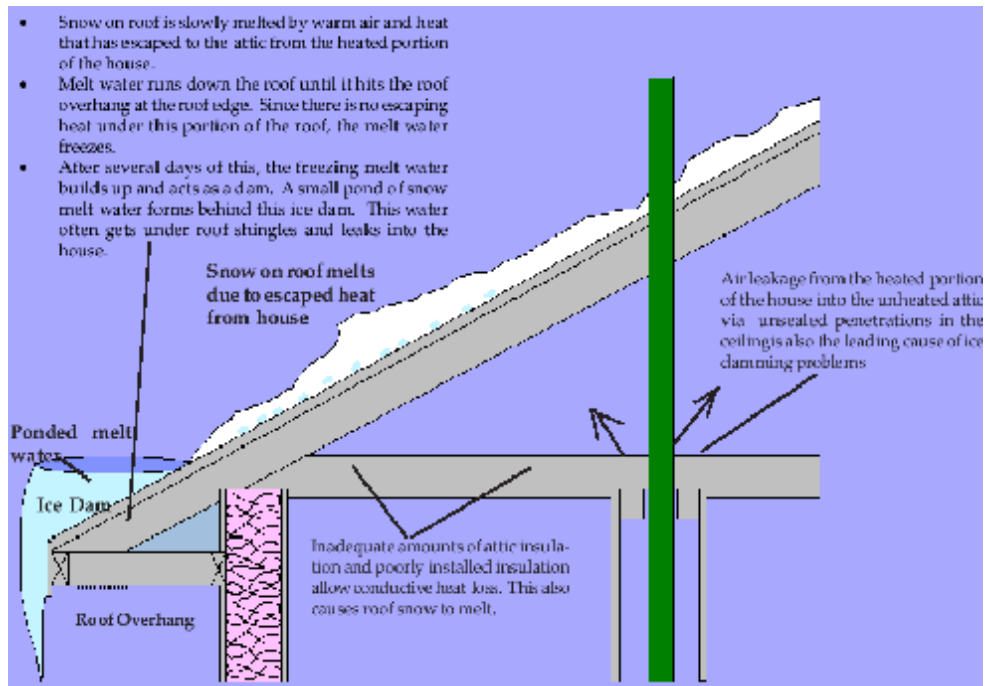
As shown in the following graphic, ice damming begins when melted water from snow refreezes on a roof. This generally occurs near the eave of a building, although it can develop at any change in slope (such as in a valley). When more melted water backs up behind this ice dam, it seeks any weakness in the roof system and may flow under shingles, underlayment, or flashing, possibly resulting in damages to the interior of the building below.

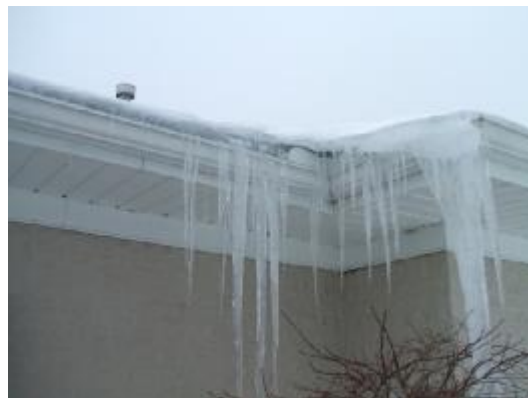
Attic studies are critical in the accurate diagnosis of ice damming. Inside the attic, check for signs of water intrusion on the roof sheathing, on the first-floor ceiling insulation along the roof perimeter, and in areas susceptible to ice damming. This may be difficult in roofs having a low slope since the attic space will decrease rapidly near the eave. In such cases, if the damages will warrant more than a cosmetic repainting of the affected drywall, it may be warranted to remove the drywall and overlying insulation to expose the roof deck above the area of interest.
