Ice Damming Basics

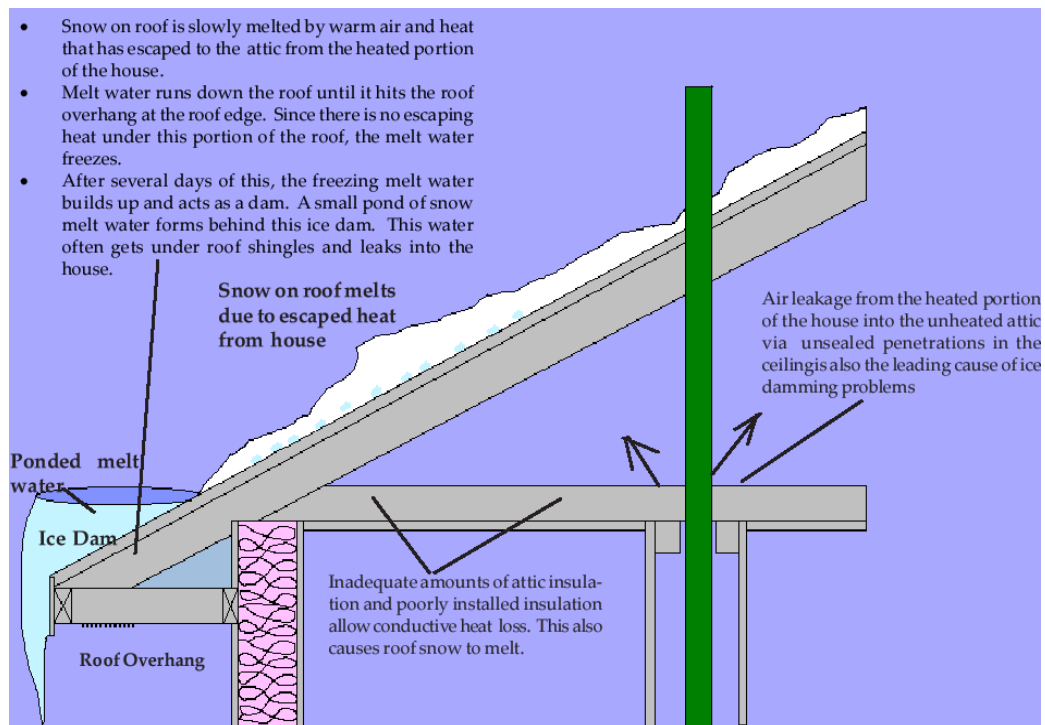
As shown in the following graphic, ice damming begins when melted water from snow refreezes on a roof. This generally occurs near the eave of a building, although it can develop at any change in slope (such as in a valley). When more melted water backs up behind this ice dam, it seeks any weakness in the roof system and may flow under shingles, underlayment, or flashing, possibly resulting in damages to the interior of the building below.

When the accumulated water on the roof penetrates the building envelope, ice damming often causes telltale symptoms that include water leaks, water stains, and fungal growth around the exterior walls and perimeter ceilings of the affected buildings. Ice damming can often be prevented by properly ventilating the attic, so that heated air is allowed to effectively escape. Ice damming can also be prevented by insulating the ceiling so that the loss of heated air inside the building into the attic is minimized, thereby reducing the opportunity for heat to warm the underside of the roof and melt the accumulated snow. Obstructed or inadequate soffit vents can cause heat buildup in the attic above the exterior walls of the house, promoting ice damming.

While most damming occurs at the gutter line, water can also back up over step flashing, beside dormers, and to other parts of a structure with a difference in elevation. Another common location for ice damming is above and below skylights, where air passages have not been provided to allow circulation.

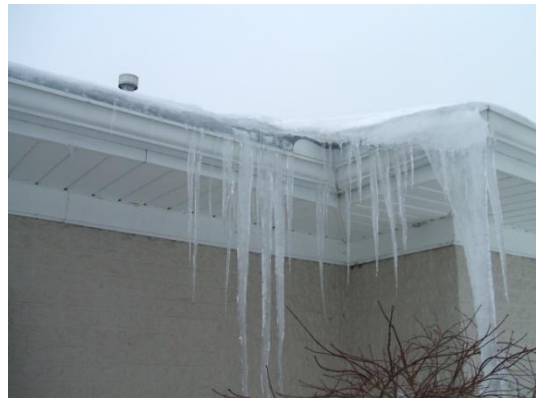
Attic studies are critical in the accurate diagnosis of ice damming. Inside the attic, check for signs of water intrusion on the roof sheathing, on the first-floor ceiling insulation along the roof perimeter, and in areas susceptible to ice damming. This may be difficult in roofs having a low slope since the attic space will decrease rapidly near the eave. In such cases, if the damages will warrant more than a cosmetic repainting of the affected drywall, it may be warranted to remove the drywall and overlying insulation to expose the roof deck above the area of interest.
